**DANDY TRAIL SITE  
FEH MITIGATION ALONG EAGLE CREEK**

**Indiana University and the Indiana Office of Community and Rural Affairs (OCRA)  
in Support of the Development of the Indiana Fluvial Erosion Hazard Mitigation  
Manual, an Indiana Silver Jackets Initiative**

**October 2018**

**Christopher B. Burke Engineering, LLC  
115 West Washington Street, Suite 1368 South  
Indianapolis, Indiana 46204**

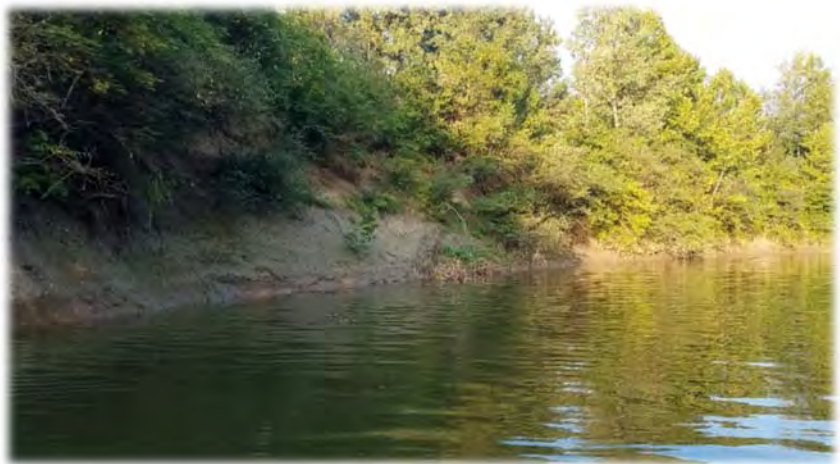
**Figure 1: Stream Bank Along Eagle Creek Levee**

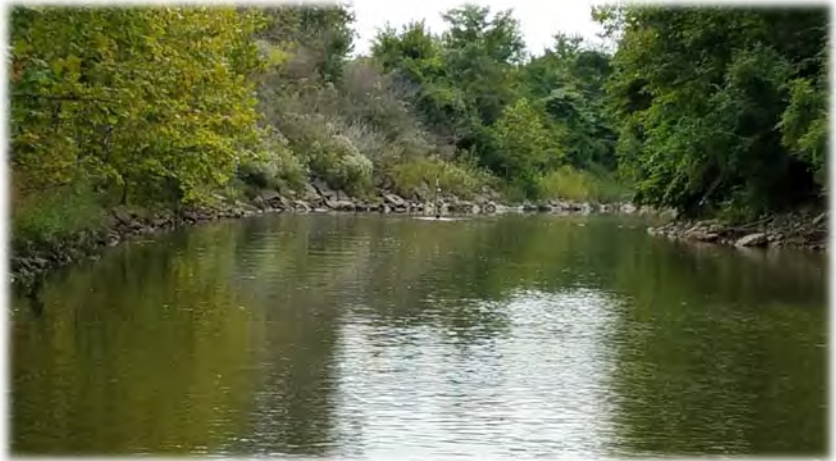
The purpose of the study is to determine the most appropriate repair methods for an existing slope failure and a means of reducing the risk of future damage to the existing levee in Indianapolis, Indiana due to erosion in Eagle Creek. A better understanding of Eagle Creek is required to determine the current characteristics of the

**Figure 2: Failed Streambank above Revetment at FEH Site**

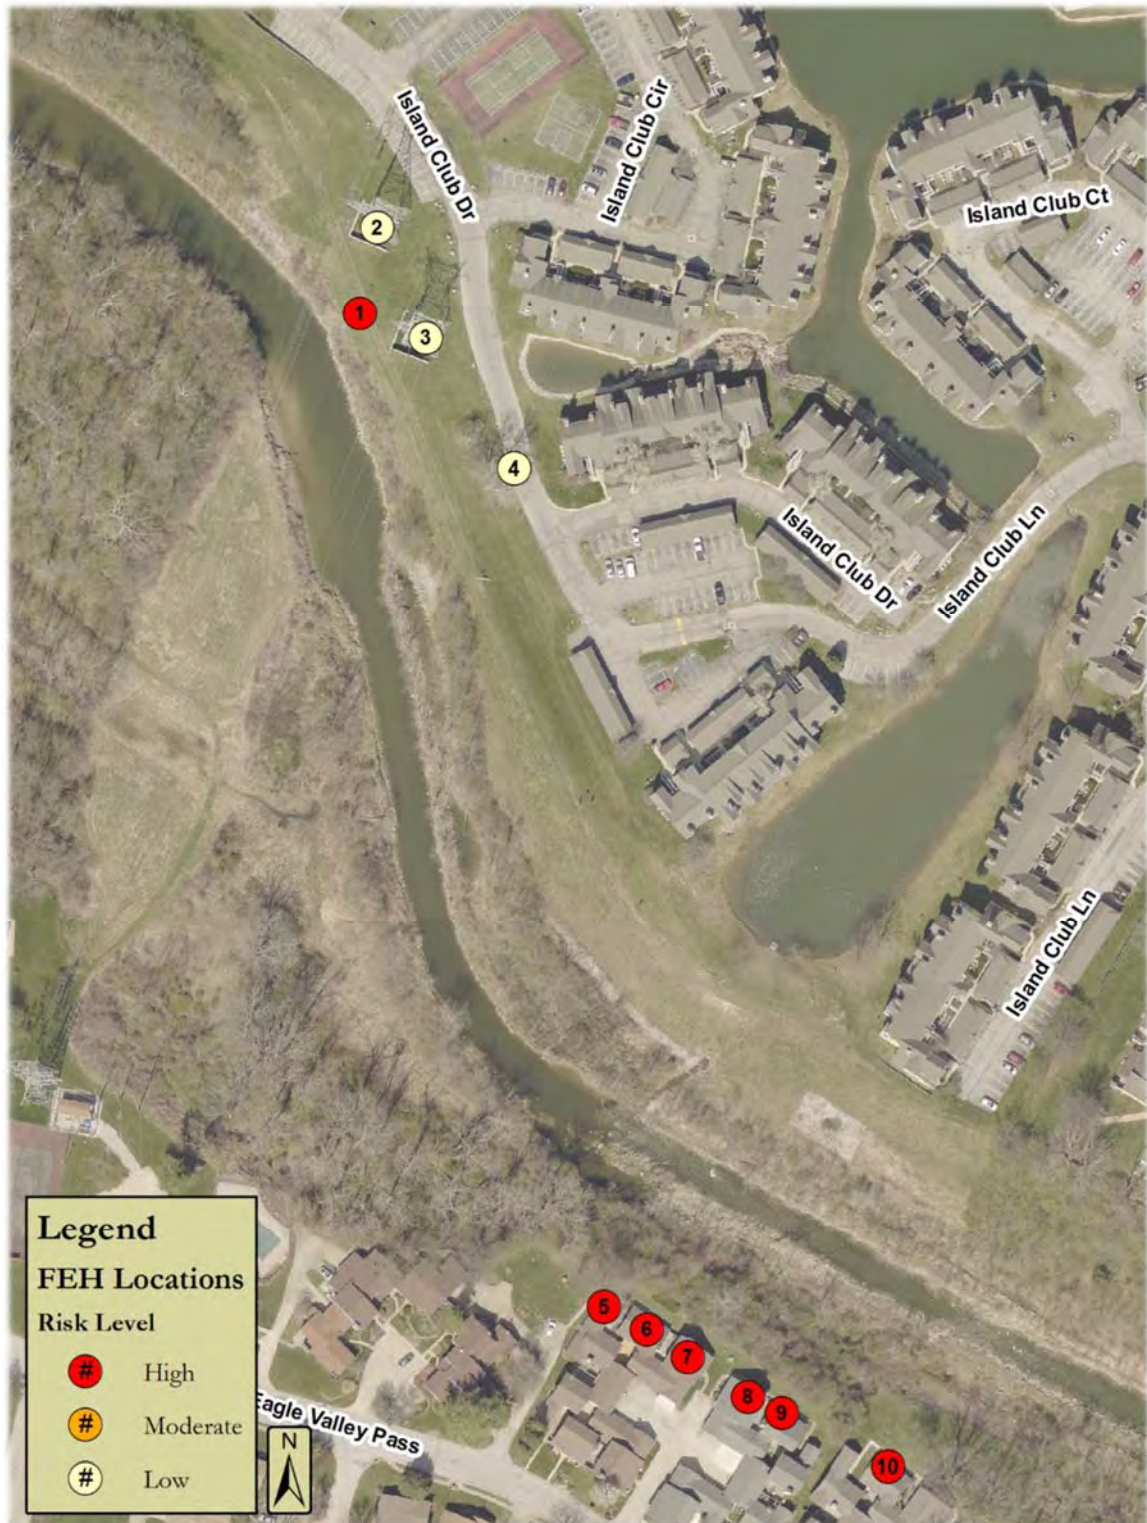
The fluvial erosion hazard corridor along Eagle Creek near the FEH site was used to establish the at-risk area where infrastructure would need to be evaluated. Each location within the assessment reach where significant infrastructure was located within the corridor was examined to determine the perceived risk level given the anticipated detrimental impact if the infrastructure was compromised. The risk level was determined according to the criteria in Table 2. Table 3 provides a summary of the at-risk infrastructure identified during the assessment, including the risk level and contributing factors; Figure 6 provides a map of the locations of the at-risk infrastructure.

Figure 6: Locations of At-Risk Infrastructure

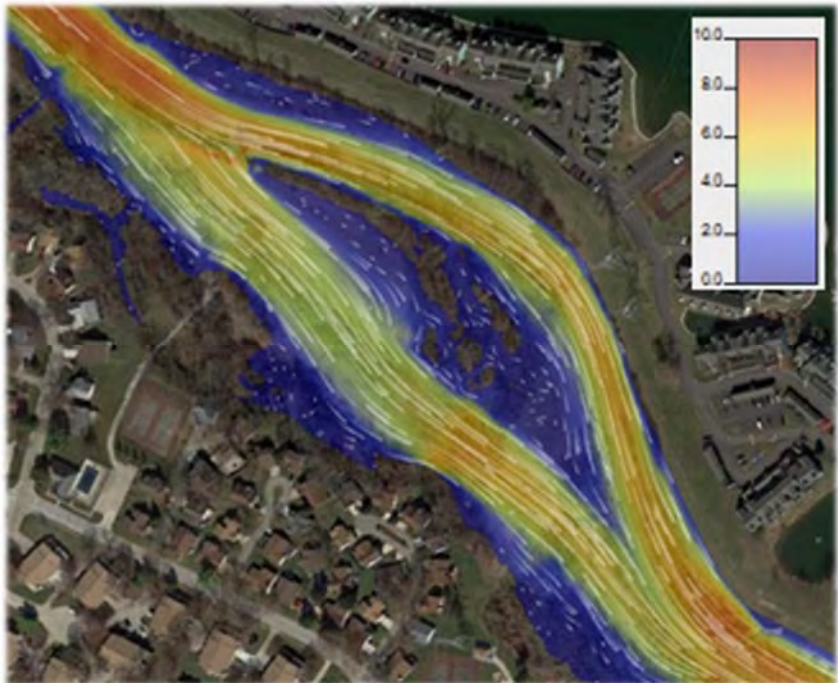
Figure 7: Overflow Path near FEH Site

The results from the hydraulic model indicate that the maximum flow velocity in the refined assessment reach ranges from 5 to 9 feet per second (ft/s) for the flows considered. During events larger than the 1.5-year, the hydraulic model indicates that

It should be noted that the maximum velocity in the main channel does not occur during the most extreme event. The highest velocity occurs in the channel just prior to when the overflow path is activated. This provides a clear example of the benefit that a floodplain can provide in terms of energy dissipation. Unfortunately, the floodplain at this location in Eagle Creek is not attached to the channel at an appropriate depth, which allows erosive flows to occur prior to the energy-dissipating activation of the overflow path.

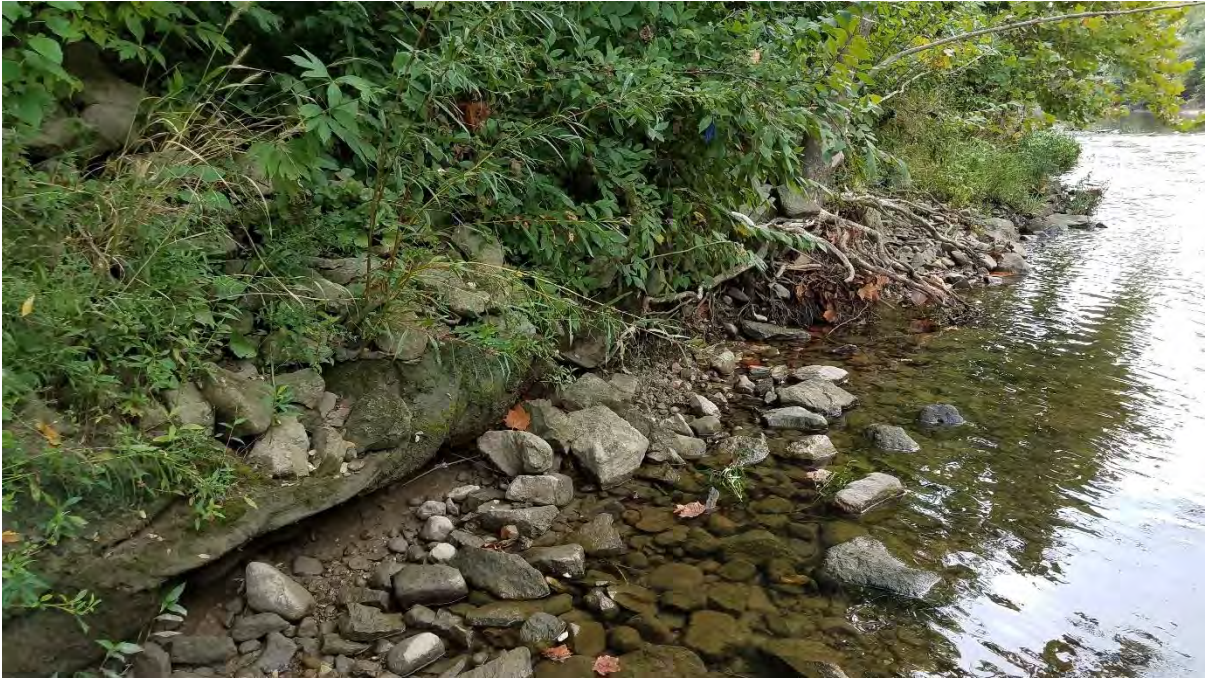
**Photo 5: Exposed erosion control blanket and riprap (east bank)**

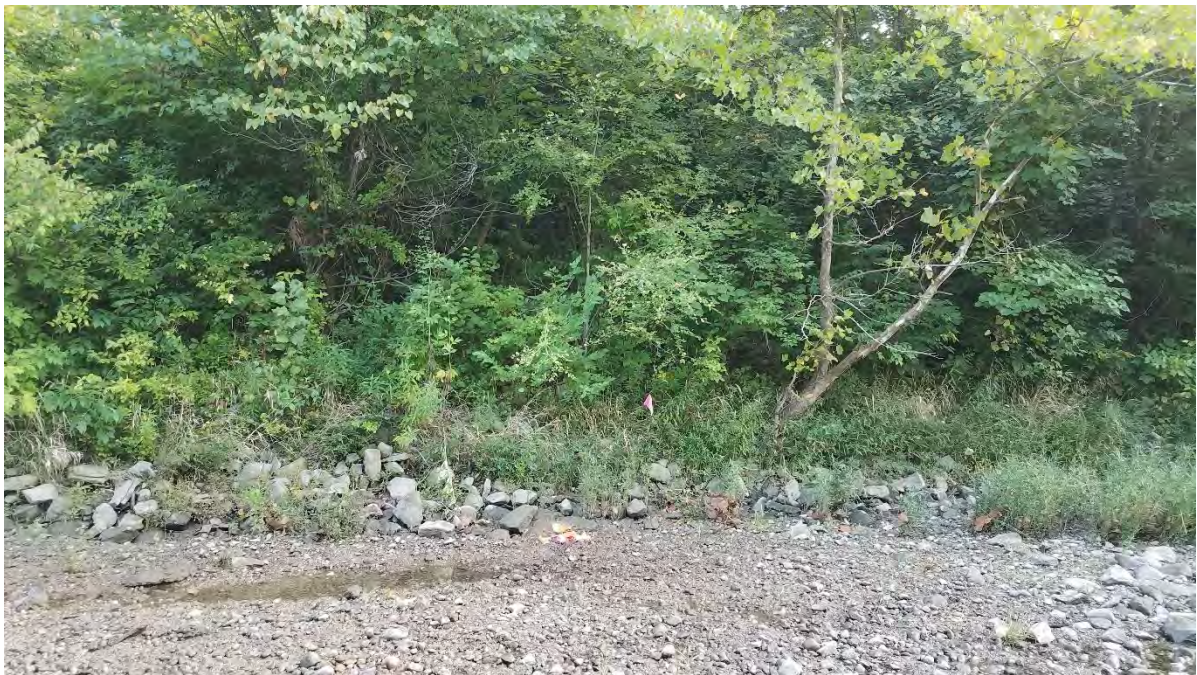
**Photo 6: Riprap along east bank**

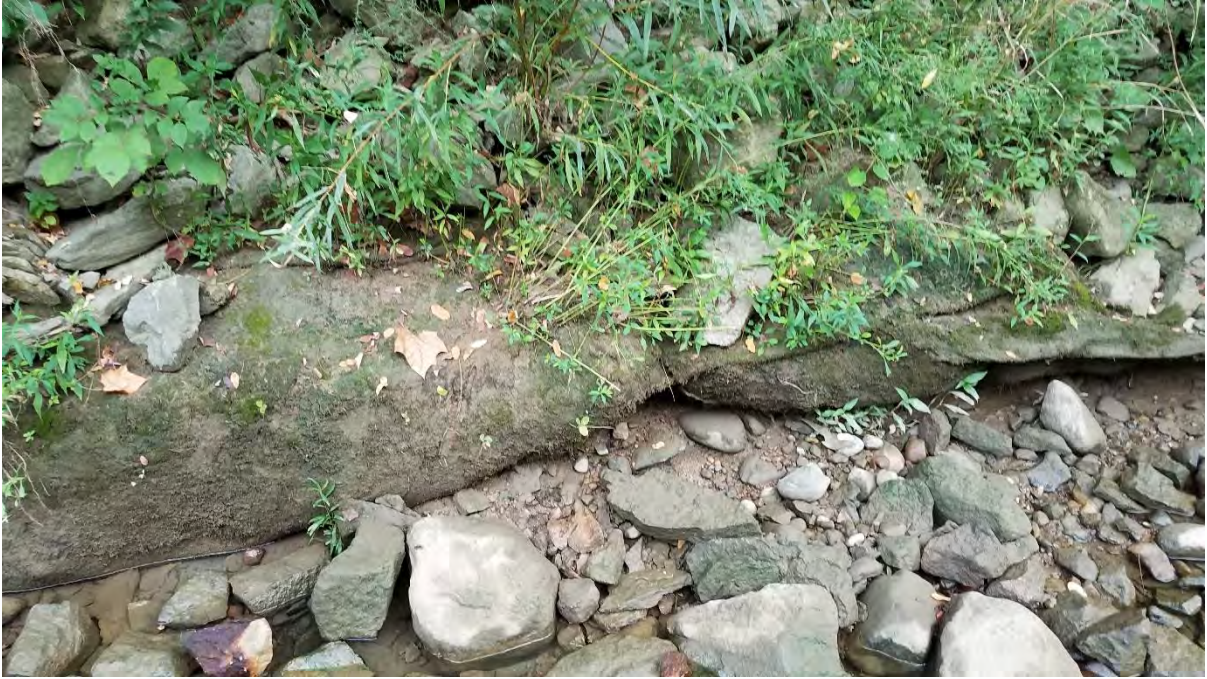
**Photo 7: Exposed erosion control blanket (east bank)**

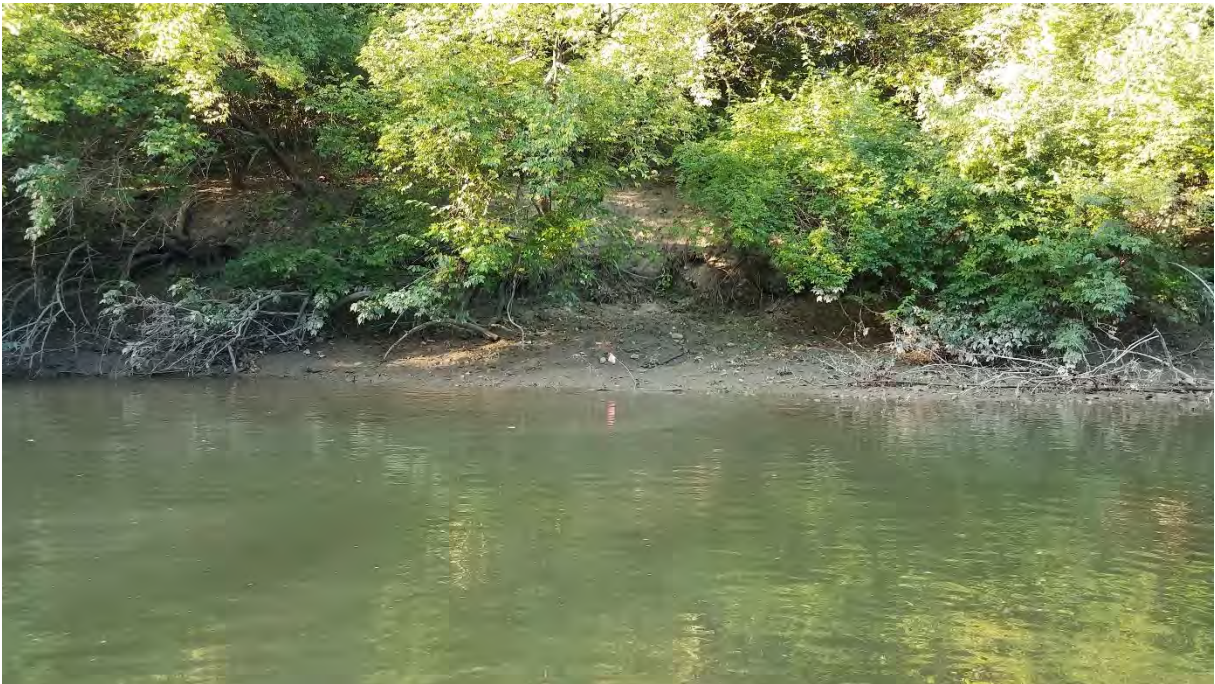
**Photo 8: Eroded west bank**
