**OLD STATE ROAD 267 FEH MITIGATION  
ALONG WHITE LICK CREEK**

**Indiana University and the Indiana Office of Community and Rural Affairs (OCRA)  
in Support of the Development of the Indiana Fluvial Erosion Hazard Mitigation  
Manual, an Indiana Silver Jackets Initiative**

**October 2018**

**Christopher B. Burke Engineering, LLC  
115 West Washington Street, Suite 1368 South  
Indianapolis, Indiana 46204**

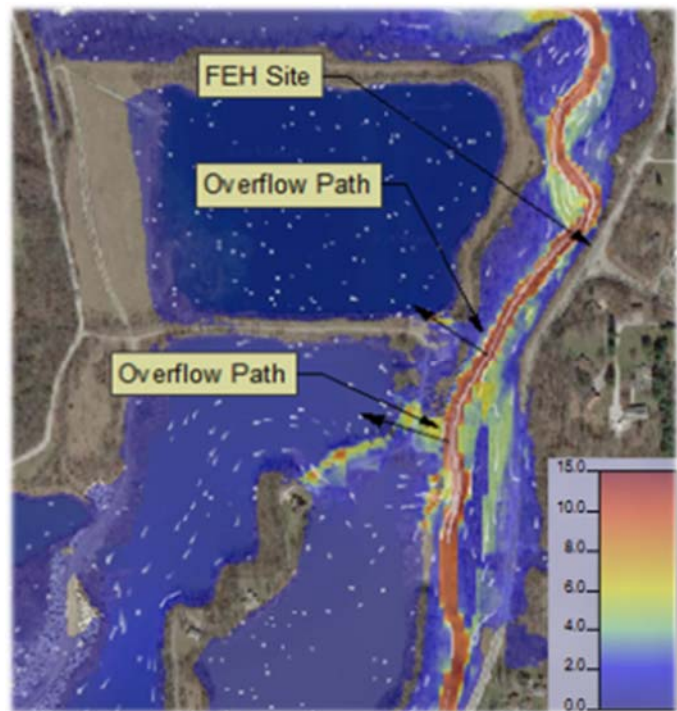
The hydraulic model also included the gravel pits and the overflow paths between the gravel pits and White Lick Creek and the area downstream of the assessment reach to reduce the impact of boundary condition assumptions. The high conveyance capacity of the gravel pit causes the flow to accelerate through the upstream and downstream overflow paths in the gravel pit barrier. The increased velocities at the overflow paths have the potential to degrade the main channel bed and initiate or continue head-cutting in the upstream direction, potentially to, or beyond, the location of Old State Road 267. The diversion of flow through the gravel pits also produces a reduction of main channel velocity in the bypassed segment of the White Lick Creek. This reduction in velocity has the potential to increase sedimentation, which may lead to the abandonment of the reach over time.

Figure 10: Overflow Path near FEH Site

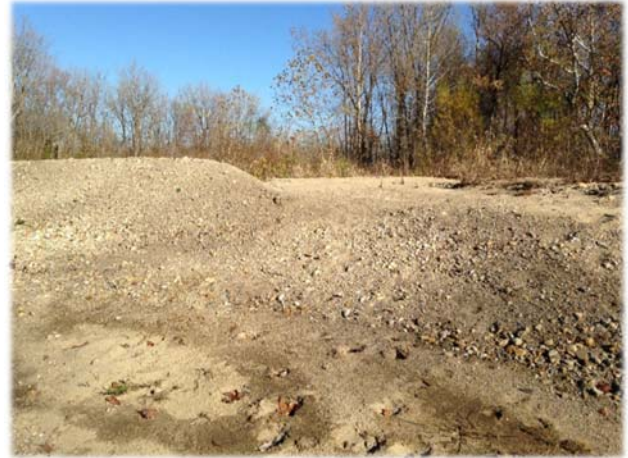
Locations in a system that have essentially no capacity to carry sediment are referred to as sediment ‘sinks’. Sediment sinks can result in massive instabilities in streams with high sediment loads, such as White Lick Creek. The large gravel pits near White Lick Creek, along and just downstream of the assessment reach, as shown in Figure 13 serve as enormous sediment sinks when intercepted. Once the flow enters the gravel pit, the sediment transport capacity vanishes, allowing nearly all the sediment being carried to be deposited. Deposition will continue to occur until the gravel pit is filled to a level that is at or above the natural stream

**Figure 12: Erodible Channel Materials**

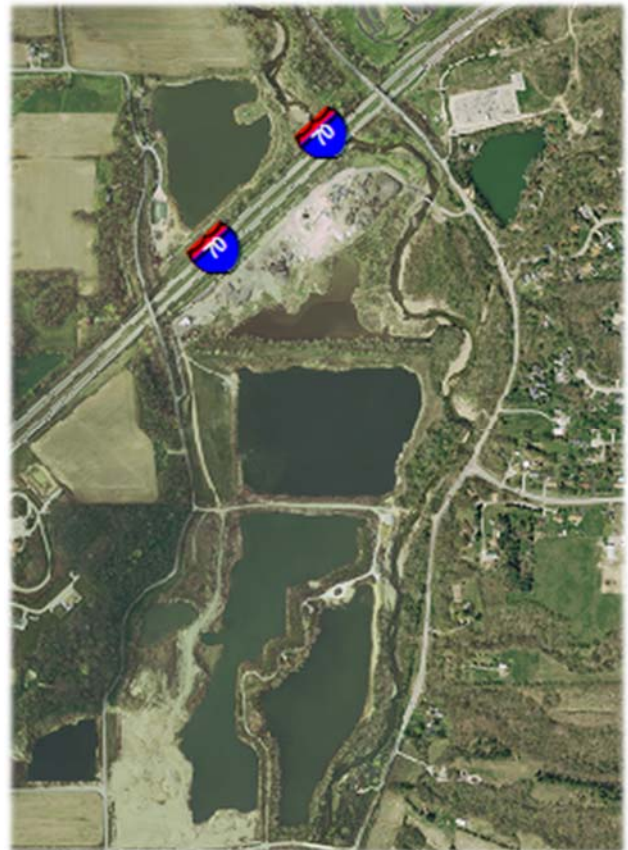
**Figure 13: Gravel Pits near FEH Site**

bed. This creates a tremendous imbalance in the sediment capacity and sediment supplied to the reach immediately downstream of the gravel pit. Once the flow re-enters the downstream channel the sediment capacity increases dramatically. The sediment supplied from the upstream reach (i.e. the gravel pit) is essentially non-existent leaving the sediment capacity to be harvested from the channel bed and banks. This is often referred to as the stream being 'hungry', as the bed and banks are rapidly eaten away. This type of stressor also leads to degradation of the channel bed upstream of the gravel pit, as described in Section 3.4.4.

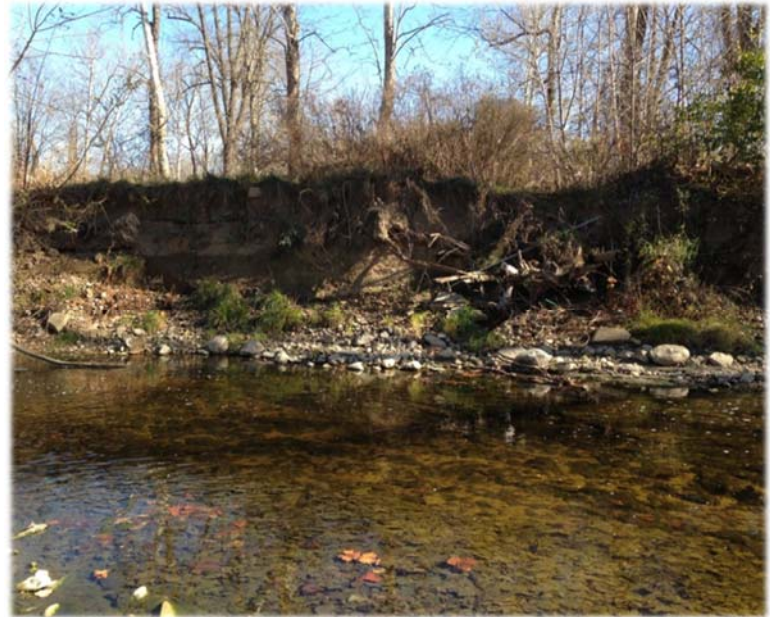
The long-term degradational trend for White Lick Creek has caused the channel to become incised and disconnected from the natural floodplain; an example of this issue is shown in Figure 14. The result of the channel incision and floodplain disconnection is that in many places the flow is confined to the channel and does not have the ability to be stored in a floodplain during a 'bankfull' event. In healthy streams, the channel and floodplain are connected. This has significant benefit during flooding, as excess flow and sediment can exit the channel and be stored in the floodplain.

**Figure 14: Incised Channel with Detached Floodplain**  
(White Lick Creek near Old State Road 267)

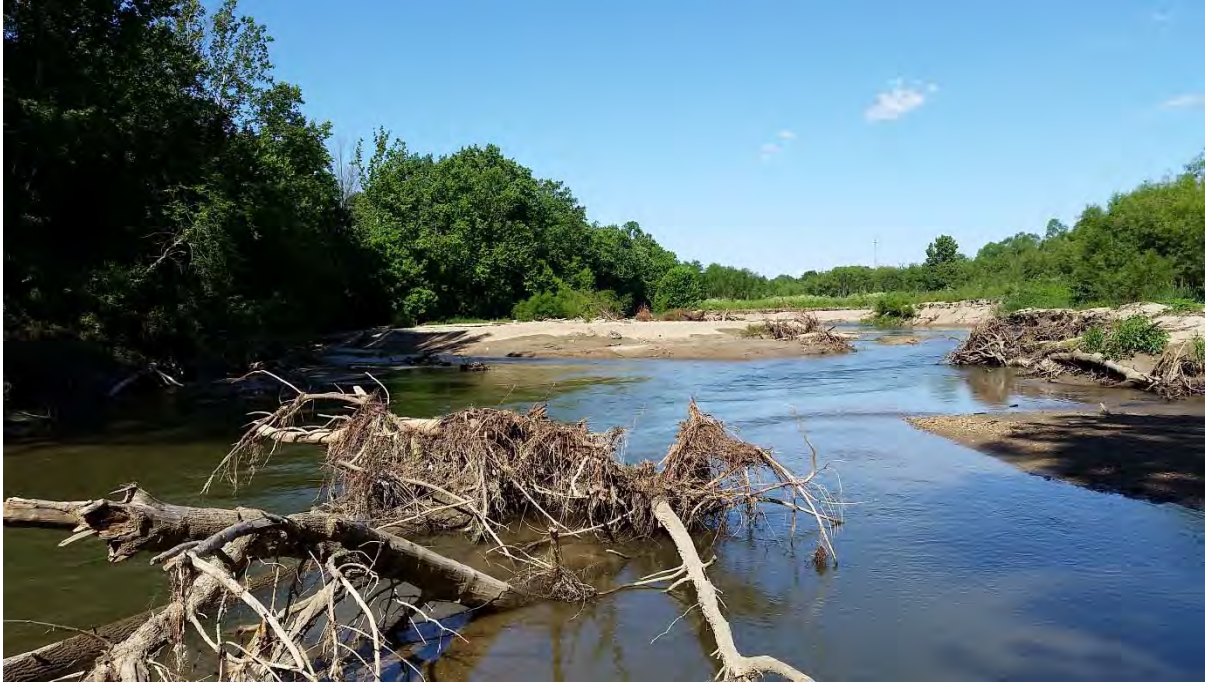
**Photo 1: White Lick Creek near FEH site (looking upstream)**

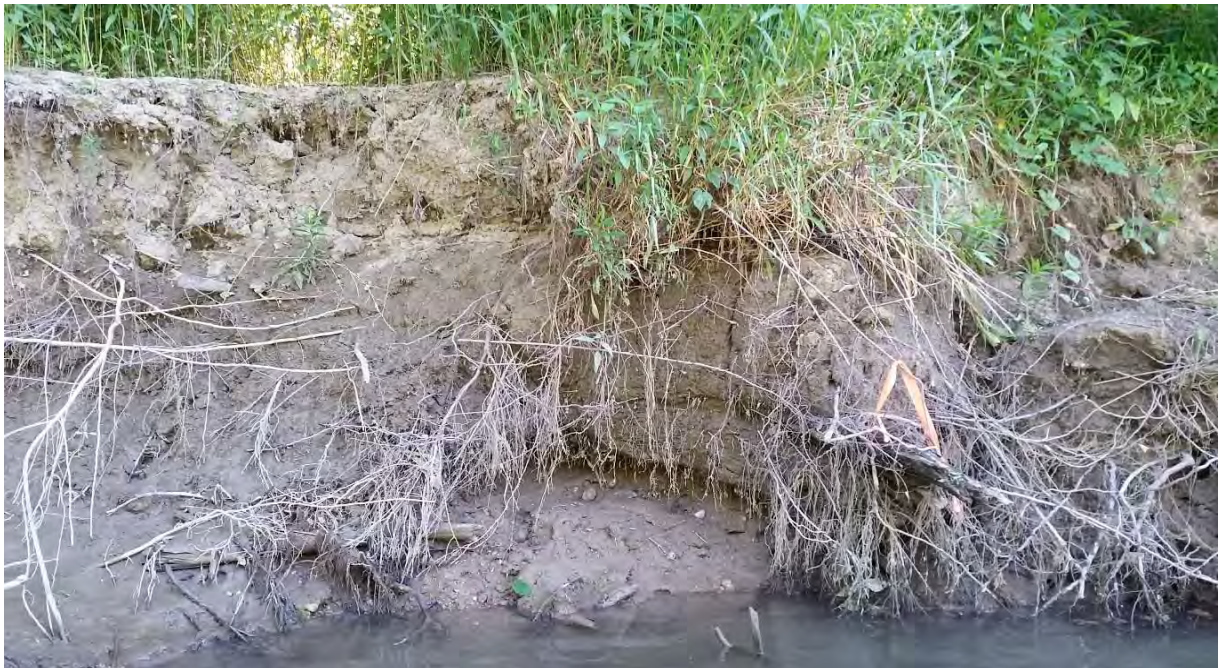
The exposed soil profiles in the eroded streambanks through the assessment reach were observed to be primarily formed of sandy, gravelly, mobile material. The toe of the slope near the FEH site is composed of dense, erosion resistant till material. The presence of highly erodible material above the toe of the slope suggests that instability in the upper bank of the FEH site will likely continue.

**Photo 2: Erosion at the FEH site**  
(Note eroded slope and lack of vegetation)

Because establishing stability in the overall system is not feasible in the short term, CBBEL evaluated localized strategies for mitigating the FEH at Old State Road 267. The improvements include toe protection, reducing the bank slope, and minor channel realignment; the anticipated cost to implement the improvements is approximately \$315,000. The dynamic nature of the stream causes the timing of implementation to be a concern; should a significant flooding / erosion event occur, the extent, cost, and difficulty of the improvements could be greatly increased. It is recommended that stakeholders meet to discuss next steps and the overall implementation strategy.

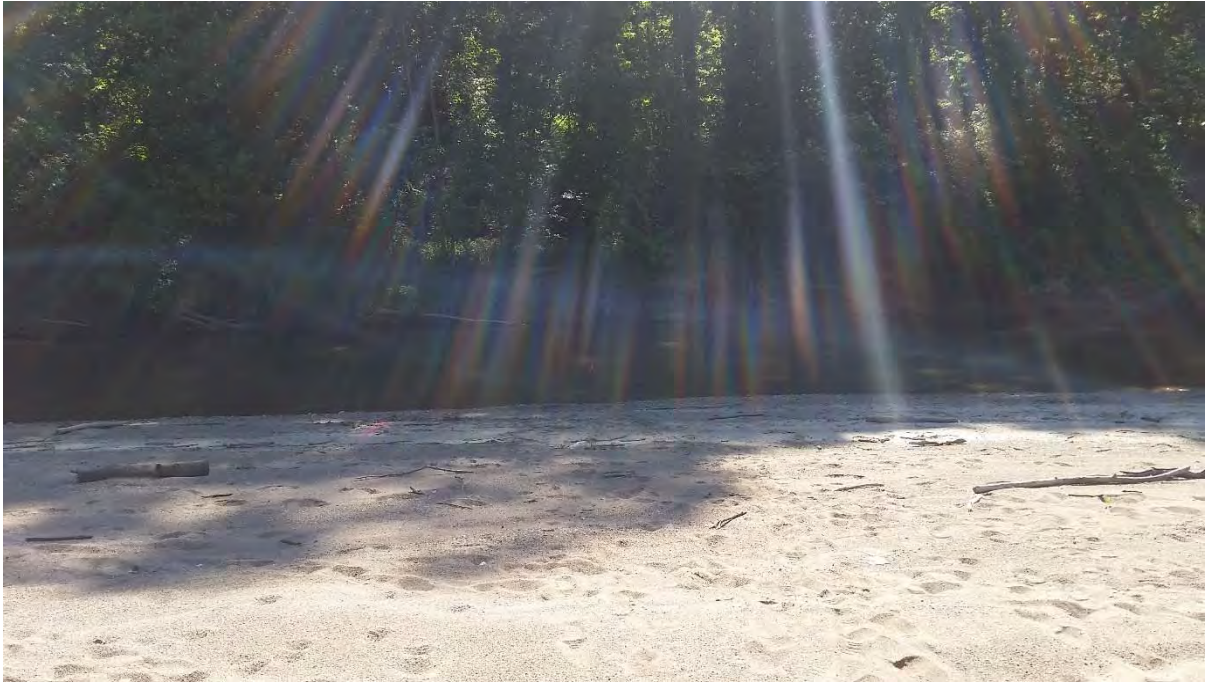
**Photo 3: Sand Bar near FEH site**

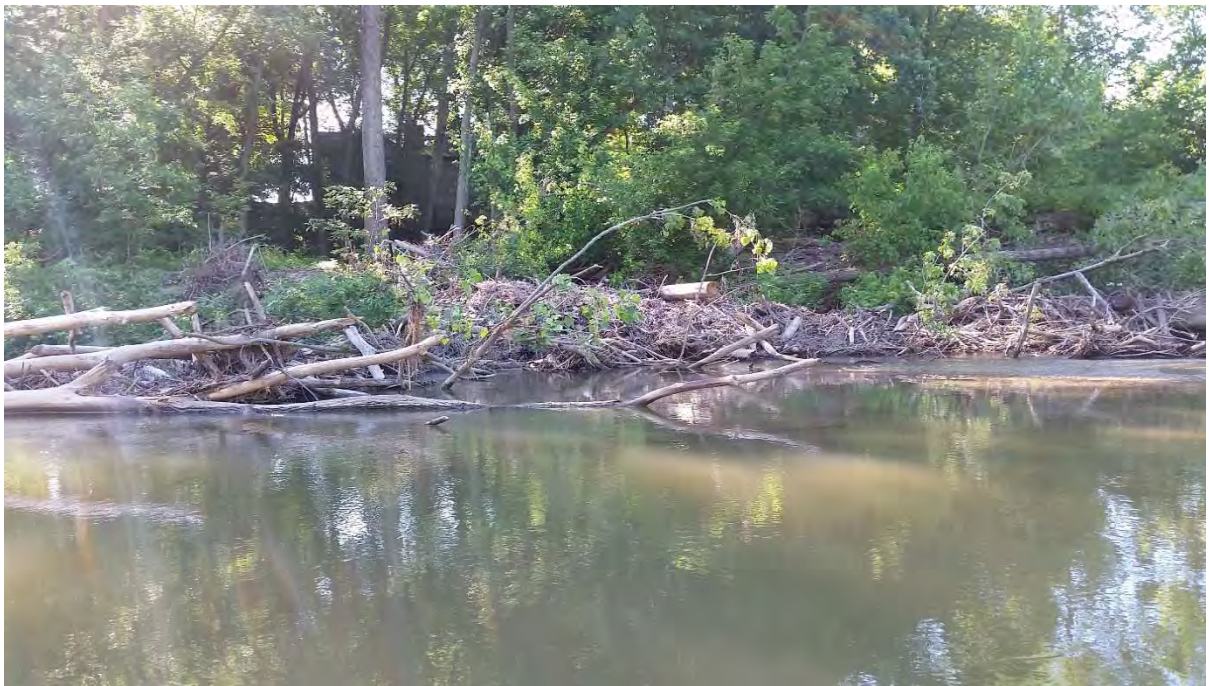
**Photo 4: Debris along bank at FEH site**

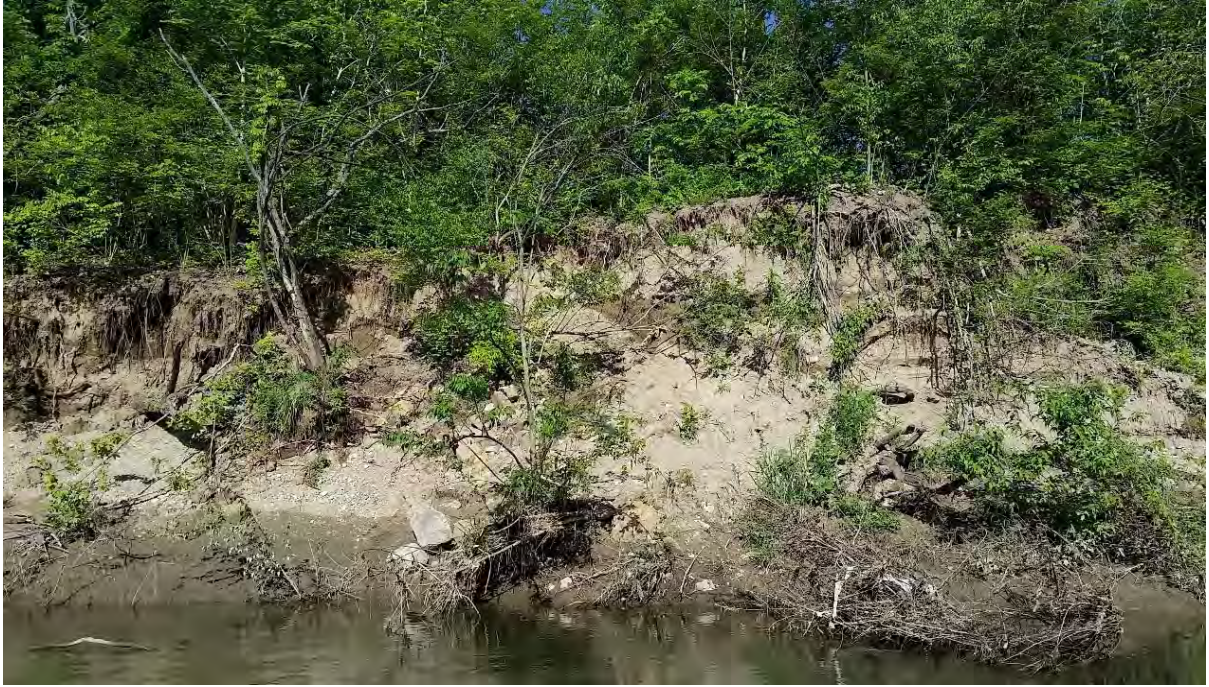
**Photo 5: Non-vegetated slope at FEH site**
