**OLD STATE ROAD 267 FEH MITIGATION  
ALONG WHITE LICK CREEK**

**Indiana University and the Indiana Office of Community and Rural Affairs (OCRA)  
in Support of the Development of the Indiana Fluvial Erosion Hazard Mitigation  
Manual, an Indiana Silver Jackets Initiative**

**October 2018**

**Christopher B. Burke Engineering, LLC  
115 West Washington Street, Suite 1368 South  
Indianapolis, Indiana 46204**

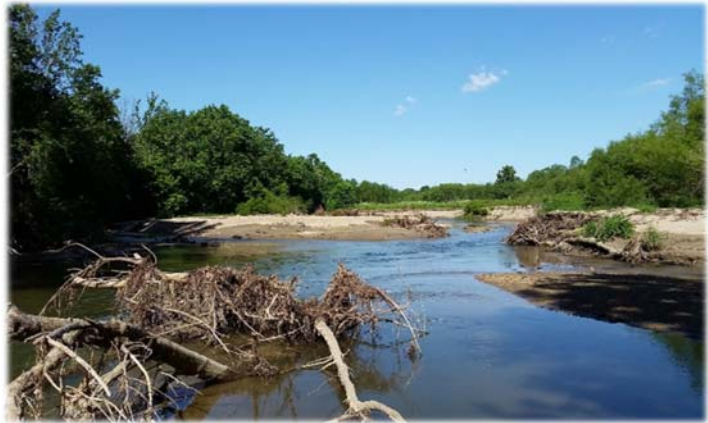
**Figure 1: Unstable Reach of White Lick Creek**

mi<sup>2</sup>), which combine with the main channel in the lower portion of the watershed. The West Fork joins White Lick Creek in Hendricks County just below Plainfield, and the East Fork joins the main channel at Mooresville. The White Lick Creek Watershed includes the western portion of the Indianapolis Metropolitan Area, including Brownsburg, Avon, Plainfield, Danville, and Pittsboro. A map of the study area is shown in Exhibit 1. Flooding and channel migration have been reported as a consistent issue with White Lick Creek for many years, most notably after the June 2008 flooding. Multiple bank stabilization and stream stabilization projects have been completed; however, the flooding and instability issues in the system have continued or worsened, most notably near Old State Road 267 (Center Street).

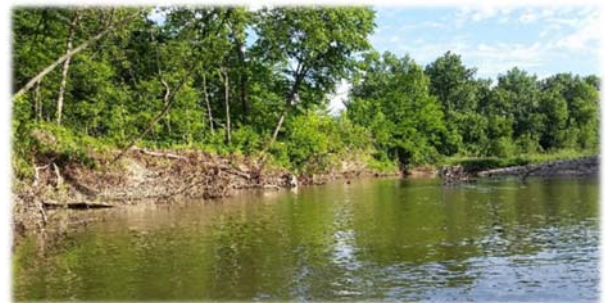
**Figure 2: FEH Site**

The purpose of the study is to determine a means of reducing the risk of damage to Old State Road 267 in Plainfield, Indiana due to erosion along White Lick Creek. A better understanding of White Lick Creek is required to determine the current characteristics of the channel and watershed,

to identify the root causes of the channel instability, and to determine what, if any, mitigation strategies are warranted, applicable, and able to be implemented without detrimental impact to adjacent stream reaches.

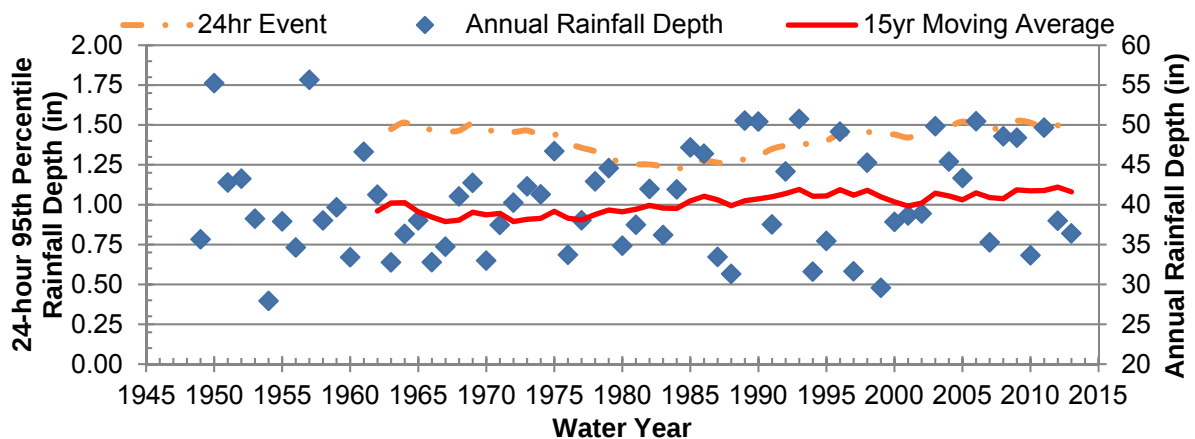
Figure 4: Annual Rainfall and Rainfall Intensity 15-year Moving Average Trends

The average annual precipitation in the White Lick Creek Watershed has been increasing over the last 25 years by approximately 0.2 inches per year. The intensity of heavy rainfall events has also increased over the last 30 years by 12% to 24%, depending on the duration of the event; however, the data suggested that the rainfall intensities are essentially the same or only slightly greater than they were 50 years ago. The discussion of the rainfall analysis clarified that the use of a single gaging station does not necessarily reflect climatic trends of an entire region but cited a previous study of National Weather Service data from 1958 to 2016 that shows the Midwest has seen the amount of precipitation during the heaviest 1% of storms increase by 42%. Figure 4 shows the 15-year moving average trends for the annual rainfall depth and the depth of the 95<sup>th</sup>-percentile 24-hour storm rainfall intensity.

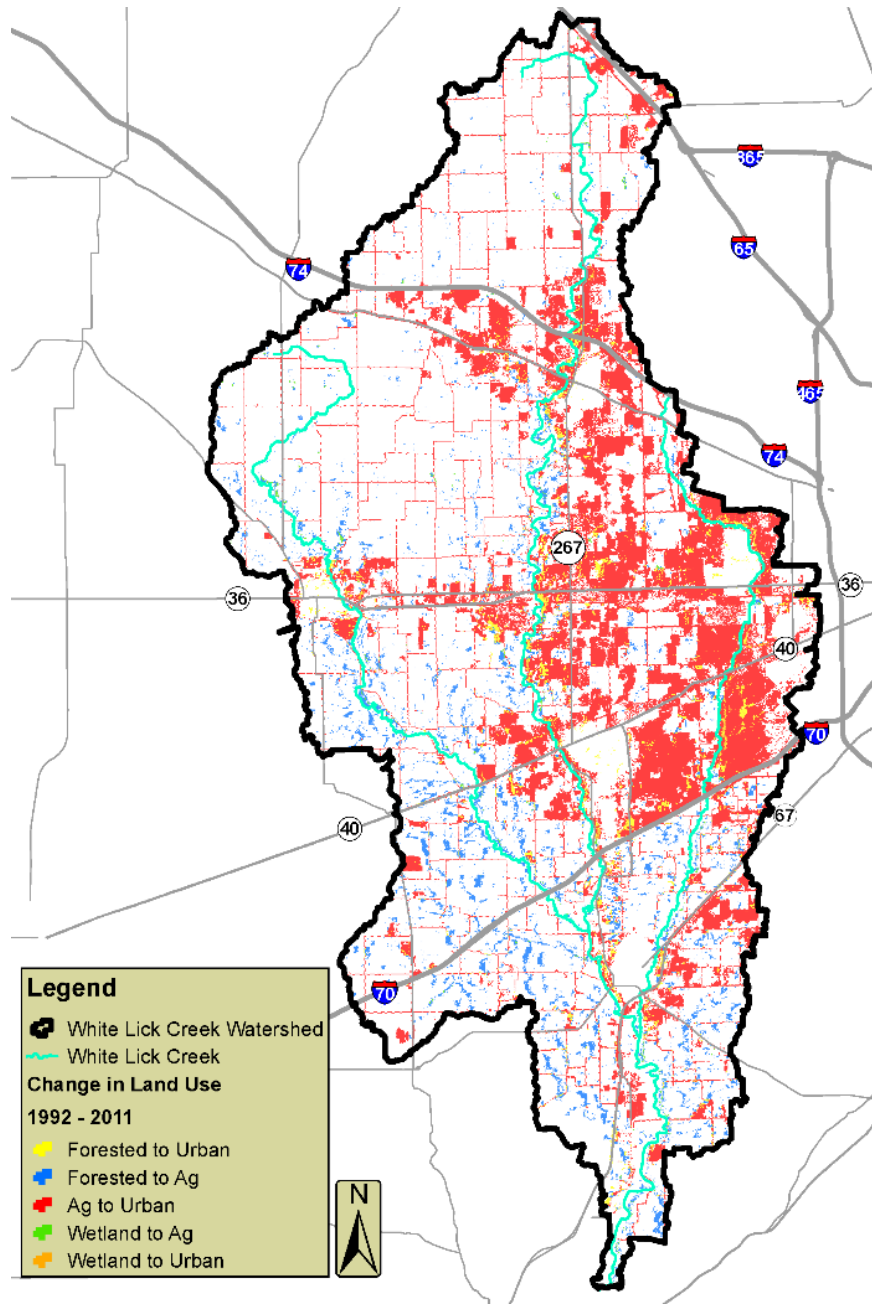
**Figure 5: Land Use Conversion from 1992 - 2011**

One of the most significant causes for systemic issues noted in the 2015 study was the drastic shift in the proportion of agricultural and urban lands that occurred between 1992 and 2001 and continued to a lesser extent to 2011 and beyond. The rapid development was noted to correspond with the population boom in Danville, Brownsburg, Plainfield, and Avon during that period. Figure 5 shows a visual of the land use conversions that occurred between 1992 and 2011. Increasing land use intensity has significant implications on the way that the watershed responds to rainfall, which is highlighted by the following discussion of the evaluation of watershed hydrology.

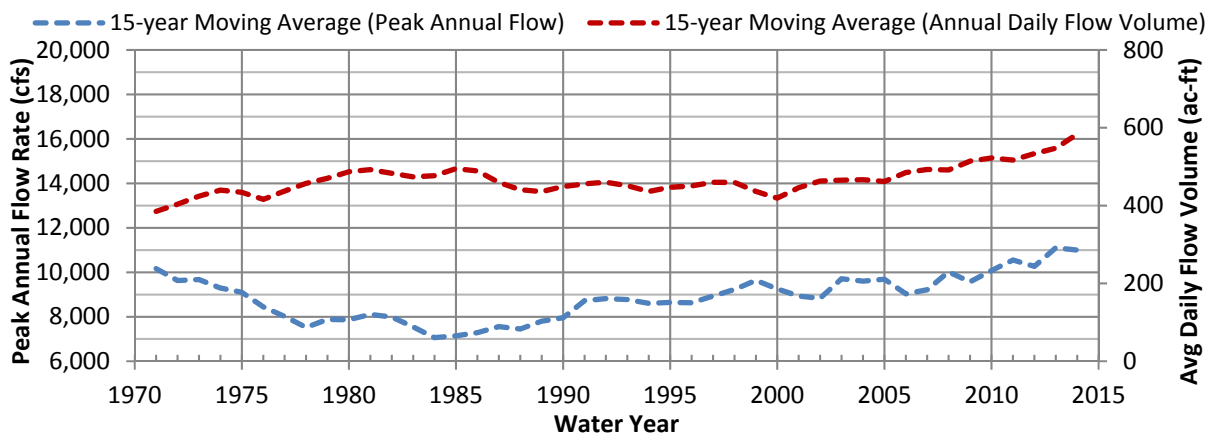
**Figure 6: 15-year Moving Average for Peak Annual Flow and Daily Flow Volume**

An analysis of the White Lick Creek streamflow gage in Mooresville, Indiana showed that the 15-year average peak annual flow rate has been increasing since 1985. The most dramatic shift occurred between 1992 and 2001, during which time the average peak annual flow was increased from 8,800 cubic-feet per second (cfs) to almost 11,000 cfs; which equates to an average of 1% increase each year for the past 22 years. The 2015 CBBEL study noted that the increase in average peak annual flow supports the validity of complaints of increased flooding in the communities along White Lick Creek each year. The trendline for the peak annual flow rate is provided in Figure 6.

A significant upward trend in the volume of runoff was also noted and attributed to the increased annual rainfall depth as well as the expansion of impervious and drained areas. The analysis showed that the average daily flow volume for White Lick Creek increased from 460 ac-ft in 1992 to 580 ac-ft in 2014, a 26% increase in flow volume. The 15-year moving average for the average daily flow volume is shown in Figure 6.

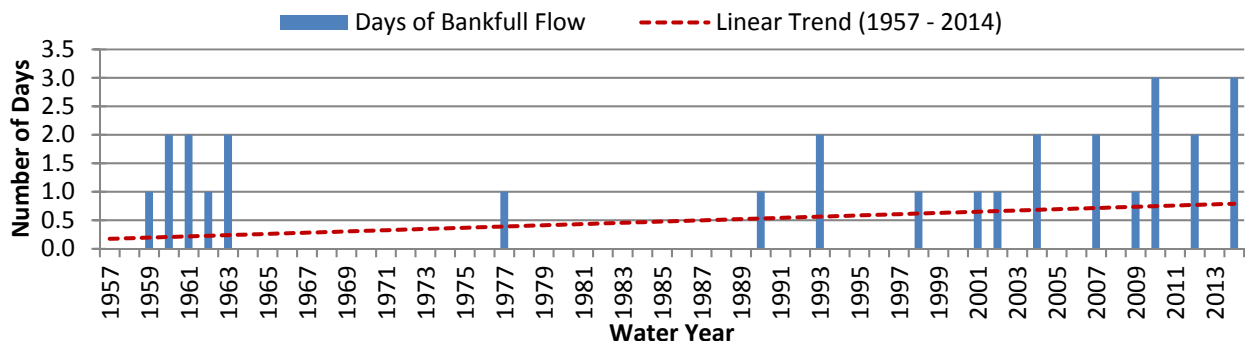
**Figure 7: Annual Frequency and 15-year Moving Average of Duration of Bankfull Flow**

The 2015 CBBEL study also included an evaluation of the frequency of the bankfull discharge by completing a statistical analysis of the White Lick Creek gage data. The analysis concluded that the 1.5-year flow rate (approximately 7,000 cfs) has been occurring more frequently and for a longer duration since 1992 and now occurs [on average] for a full day each year, rather than for only a few hours every other year. Figure 7 provides a plot of the annual frequency of bankfull flows, as well as the trendline for the duration of bankfull flows measured in hours per year.

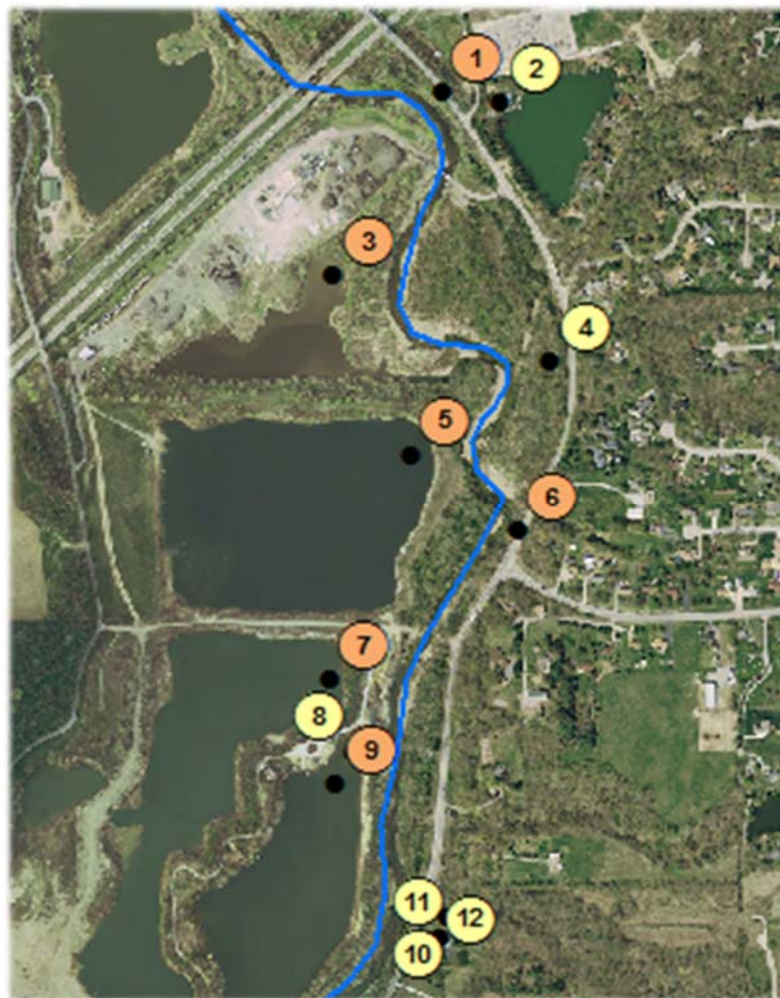
**Figure 8: At-Risk Infrastructure**

The fluvial erosion hazard corridor along White Lick Creek near the FEH site was used to identify the at-risk area which infrastructure would need to be evaluated. Each location within the assessment reach where significant infrastructure was located within the corridor was examined to determine the migration rate of the channel and the perceived risk level given the anticipated detrimental impact if the infrastructure was compromised, as shown in Figure 8. The risk level was determined according to the criteria Table 1. Table 2 provides a summary of the at-risk infrastructure identified during the assessment, including the risk level and contributing factors.

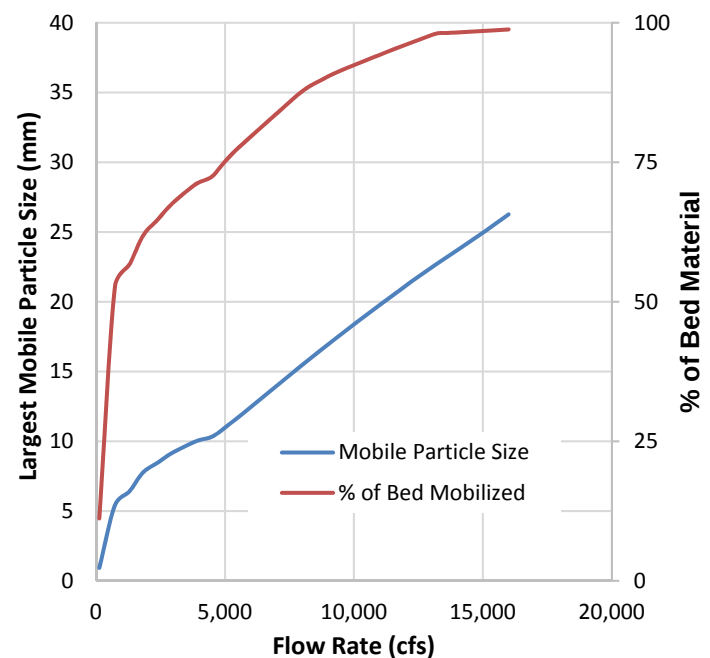
Figure 11: Sediment Competence Curve

An evaluation of long-term channel degradation was completed to evaluate the potential for the channel bed to be naturally armored by particles that are large enough that they are not mobilized. The smallest armoring-particle size was determined using Borah's method from TS-14B of Part 654 of the National Engineering Handbook. Figure 11 shows the relationship between the flow rate in the channel and the largest mobile particle on the channel bed. Sediment competence calculations are provided in Appendix 4.

Due to the fact that less than 65% of the channel materials are not of sufficient size to resist mobilization during the 1-year event (about 2,000 cfs), it does not appear likely that the channel will be naturally armored; channel degradation will likely continue until the channel reaches the equilibrium slope. An equilibrium slope was not evaluated as the gravel pit causes any determination to be highly speculative.

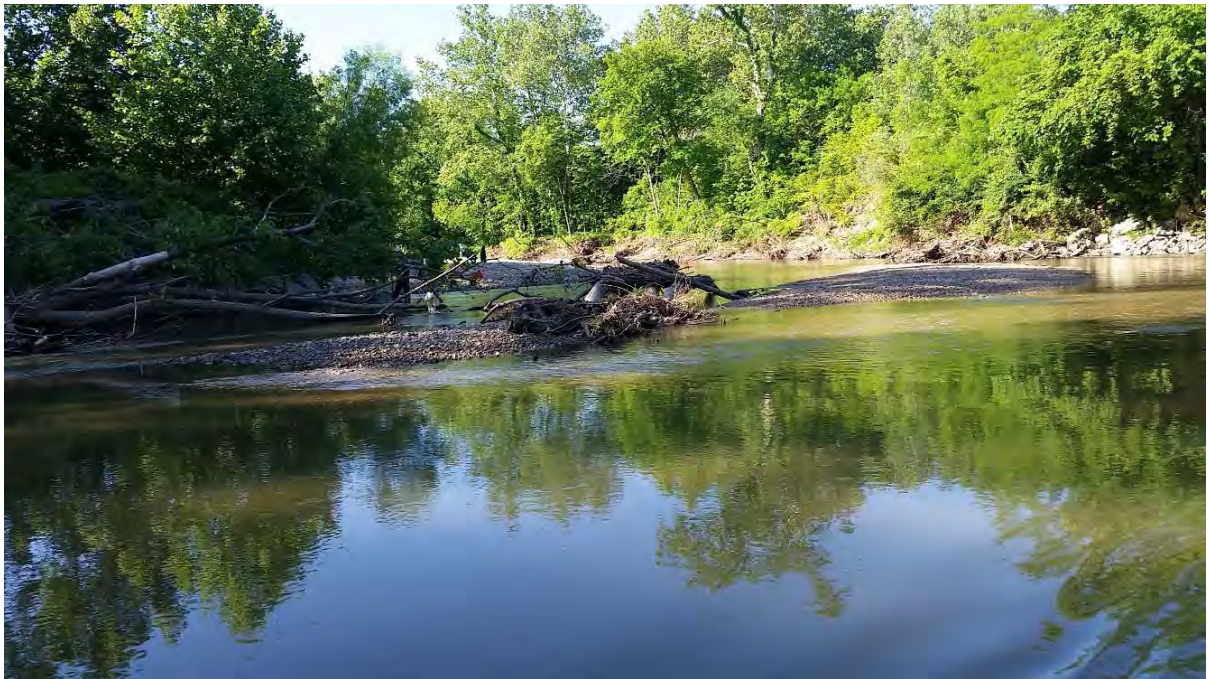
**Photo 6: White Lick Creek at FEH site**

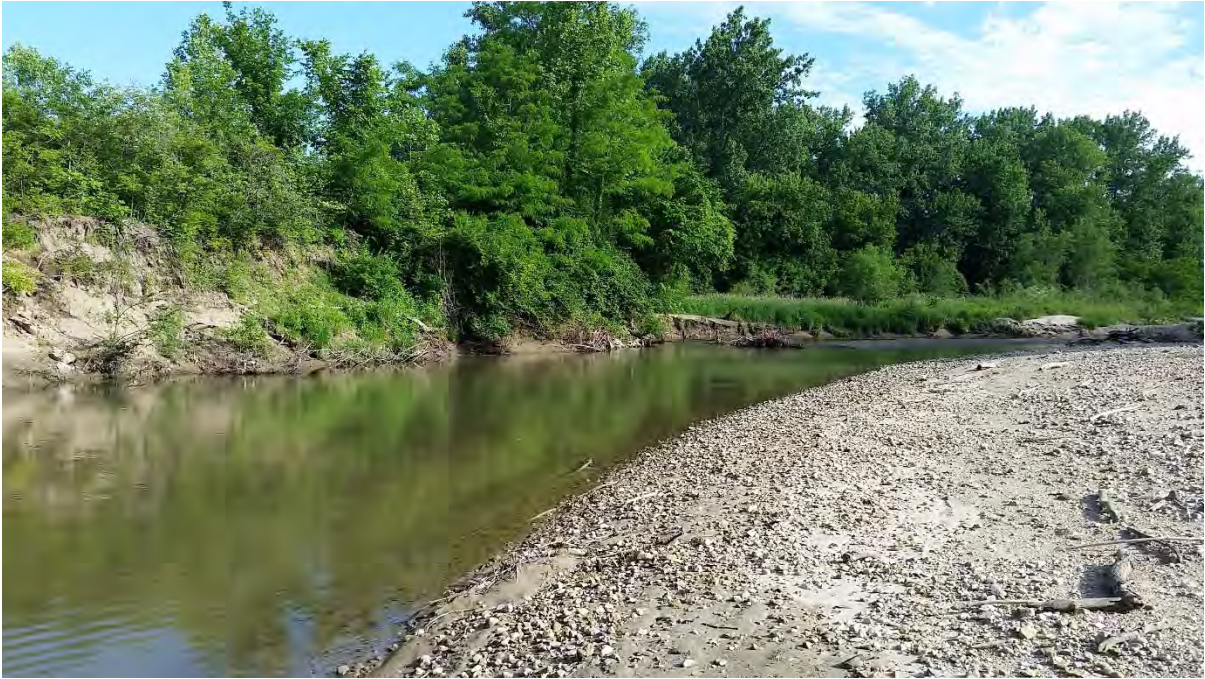
**Photo 7: White Lick Creek at FEH site**

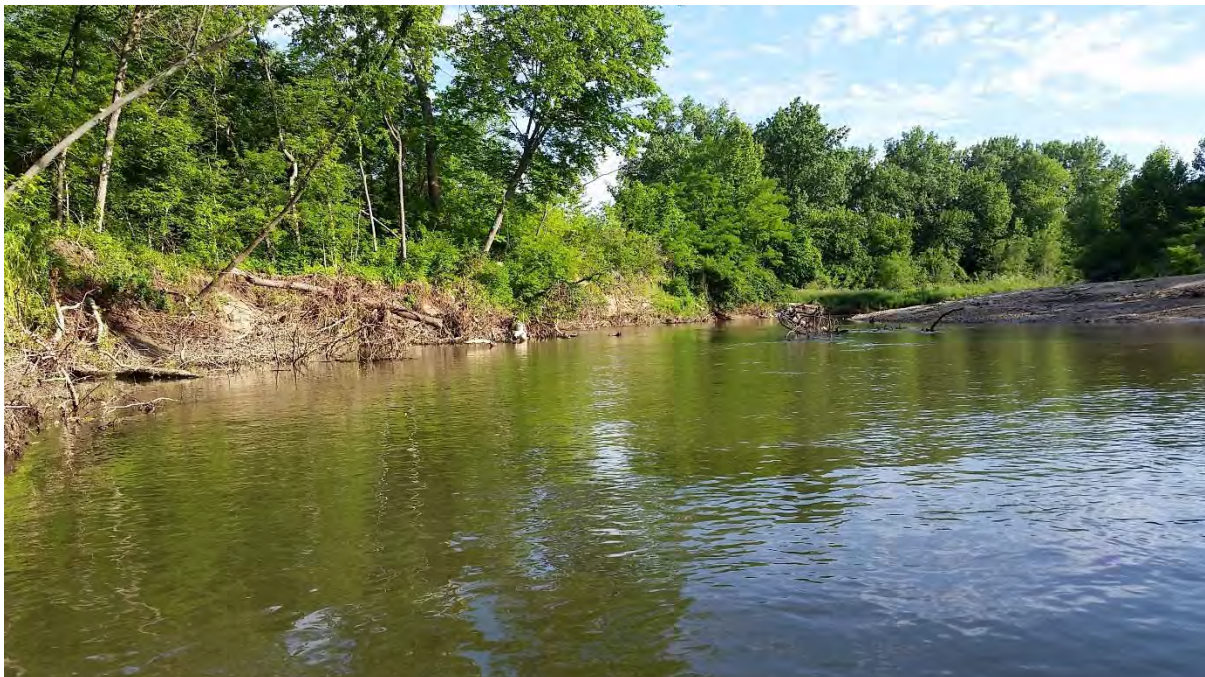
**Photo 8: White Lick Creek along FEH site**

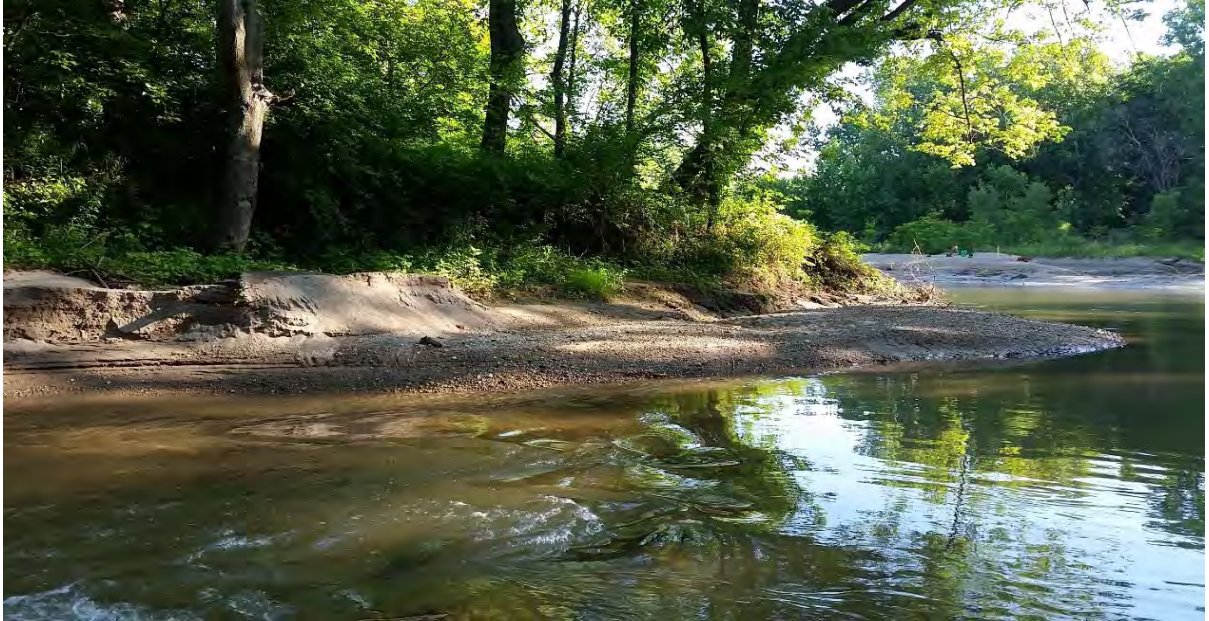
**Photo 9: White Lick Creek along FEH site**
